Manhole Inspection Summary

Manhole # S21G__043MH

Location Address: **1801 VINE ST**

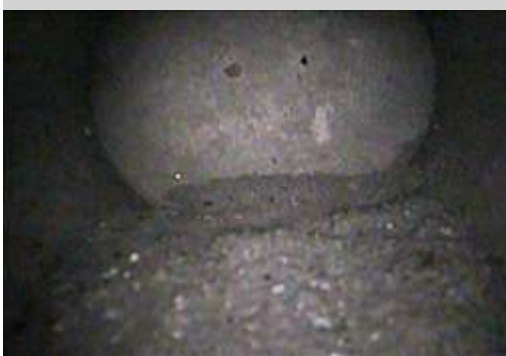
interior of the abandoned pipe

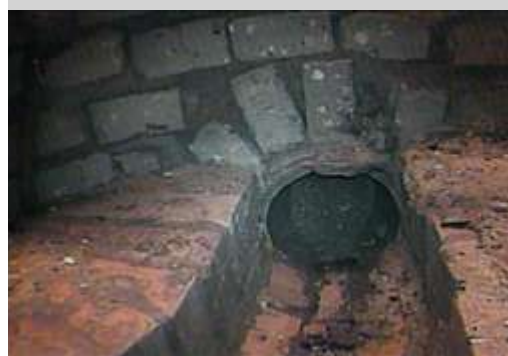
abandoned pipe at i3

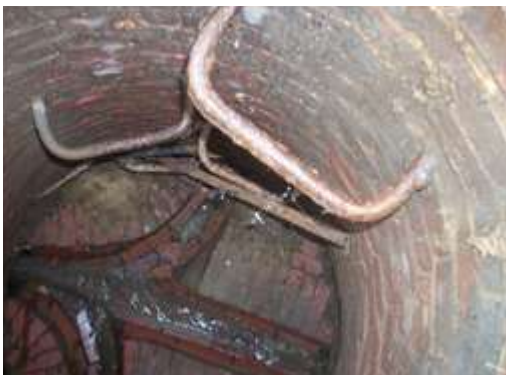
Defect 3

Count: **4** Missing: **0** ☒ **Corroded**

CORRODED STEPS

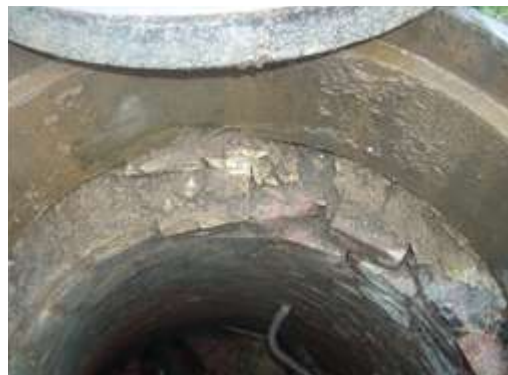
Defect 2

Offset: **3** (in.)

Condition: ☐ Sound ☐ Cracked ☐ Root Intrusion ☐ Loose Brick ☒ **Deteriorated**

FRAME OFFSET AND DETERIORATED CHIMNEY

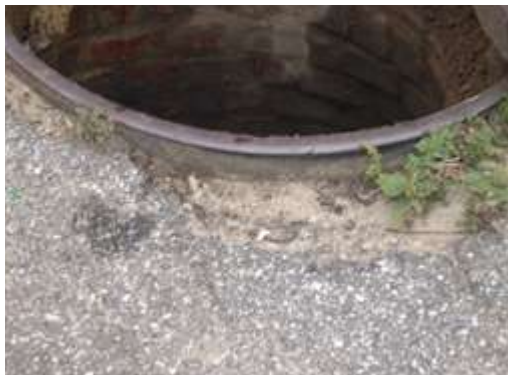
Defect 1

Diameter: **24** (in.) Length: (in.) Dist A/B Grade: **2** (in.)

GRADE ADJUSTMENT

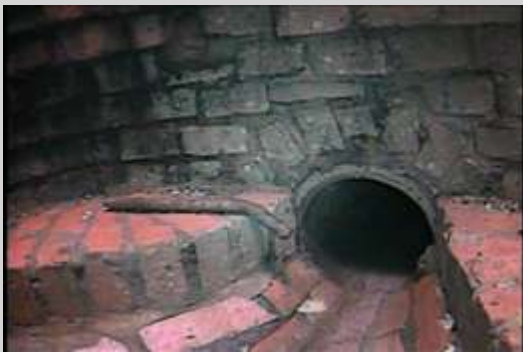
12 O'Clock Outflow

8 in. Circular Gravity Sewer
Pipe Out @ 12 O'Clock

Pipe Height: **8.4** (in.) Rod and Bar (Angled)
Pipe Material: **Clay** ☐ Pipe Lined
Invert Depth: **7.93** (ft.) Flow Characteristics: **Slow**
Deposits: ☒ None ☐ Mud ☐ Sludge ☐ Debris ☐ Grease
Silt Depth: (in.) Deposits Extent:
Infiltration: **None** Pipe Seal Cond: **Sound**

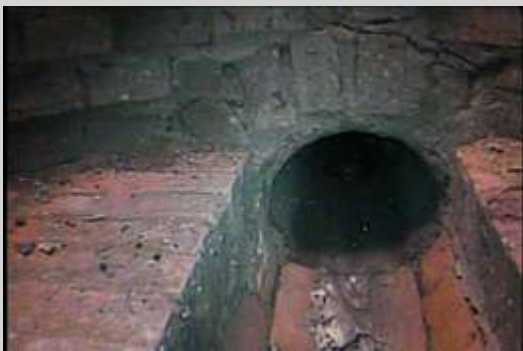
6 O'Clock Inflow

8 in. Circular Gravity Sewer
Pipe In @ 6 O'Clock

Pipe Height: **8.4** (in.) Rod and Bar (Angled)
Pipe Material: **Clay** ☐ Pipe Lined
Invert Depth: **7.71** (ft.) Flow Characteristics: **Slow**
Deposits: ☒ None ☐ Mud ☐ Sludge ☐ Debris ☐ Grease
Silt Depth: (in.) Deposits Extent:
Infiltration: **None** Pipe Seal Cond: **Sound**

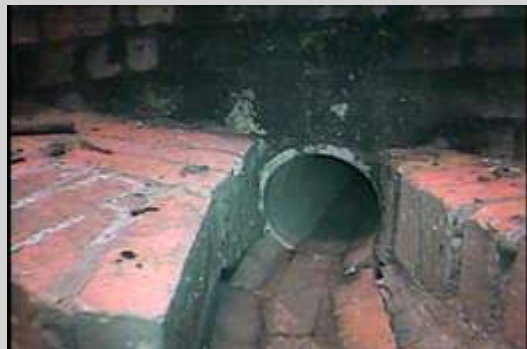
9 O'Clock Inflow

6 in. Circular Gravity Sewer
Pipe In @ 9 O'Clock

Pipe Height: **6** (in.) Rod and Bar (Angled)

Pipe Material: **PVC** ☐ Pipe Lined
